THE WIND ENGINEER

NEWSLETTER OF AMERICAN ASSOCIATION FOR WIND ENGINEERING

June 2006

Eyes in the Sky: Remote Sensing of Hurricane Damage

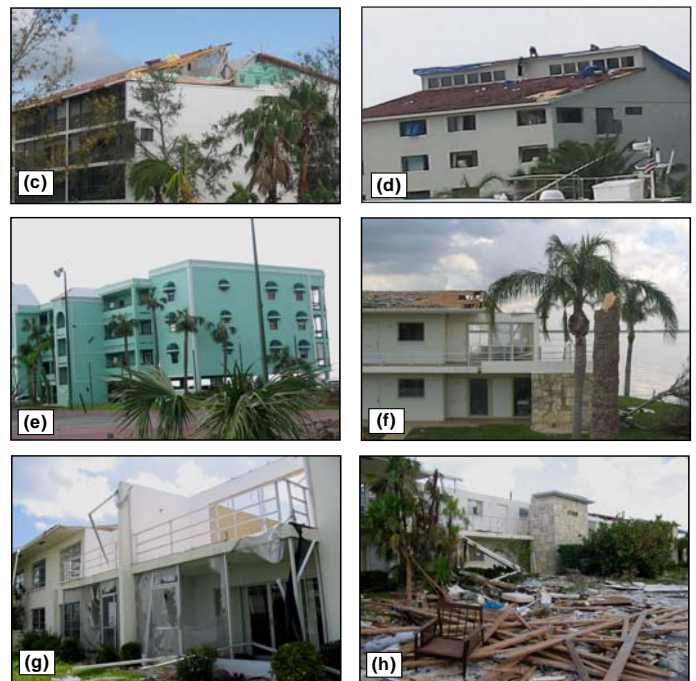
Figure 1 (continued). Comparison of pre- and post storm building conditions in satellite images, along with ground-survey photos. Ground-survey photos demonstrate: (c) partial roof deck failure (combined internal and external pressures); (d) shingles partially removed but deck intact; (e) scoured roof gravel (not visible from ground survey); (f) partial roof structure failure; (g) severe roof structure failure; (h) windborne debris from nearby building deposited on parking lot, roadway, and tennis court.

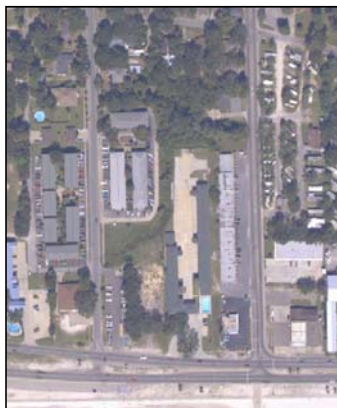
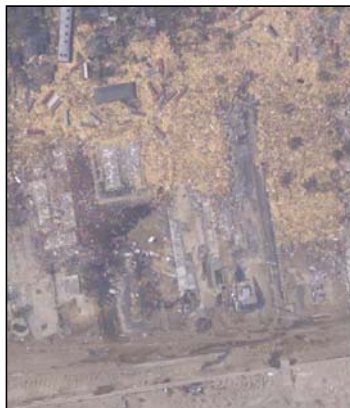
(a) September 2004

(b) August 2005

Figure 2. Comparison of 37-cm aerial images acquired before and after Hurricane Katrina shows storm-surge and wind-pressure damage in Gulfport, Mississippi (digital aerial imagery from NOAA's Remote Sensing Division).

In August 2005, Hurricane Katrina provided the opportunity to explore the juxtaposed damage signatures of wind pressures and storm surge, again by combining remote-sensing imagery with field investigations. NOAA aerial images acquired along the Mississippi coast in September 2004 and again in August 2005 (Figure 2) give an example of the remote-sensing signature of storm-surge debris. Continuing research work targets the expanded use of remote-sensing technologies for the investigation of wind-pressure as well as storm-surge damage.

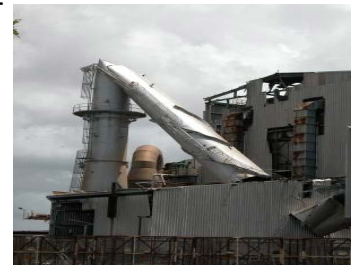
Collapsed chimney stack – Mourilyan sugar mill

The performance of engineered non-building structures was generally good in Larry, with the notable exception of a chimney stack at the Mourilyan Sugar Mill. The latter was apparently suffering from corrosion. Interestingly the chimney was equipped with helical strakes. The latter are effective at mitigating cross-wind vibrations at low-medium wind speeds, but would have significantly increased the wind loads during the Cyclone, because of the increased drag coefficient. Failure of some small communications towers, including a mobile telephone tower were also observed during Larry.

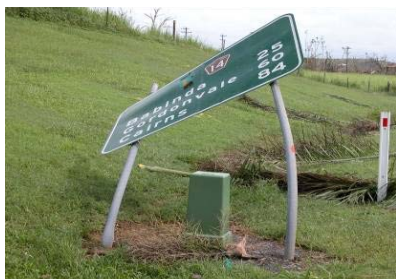
Failed road sign (used to determine local gust wind speeds)

Although initially classified by the Bureau of Meteorology as a Category 5 cyclone at landfall, subsequent analysis of recorded wind speeds and the failure of simple structures such as road signs indicated that, in fact, it was a high Category 3, or low Category 4, event. The original assessment as a Category 5 was of considerable concern to Dr. Holmes, in his role of Chair of the wind actions sub-committee of Standards Australia, as the current design wind speed for ultimate limit state design on

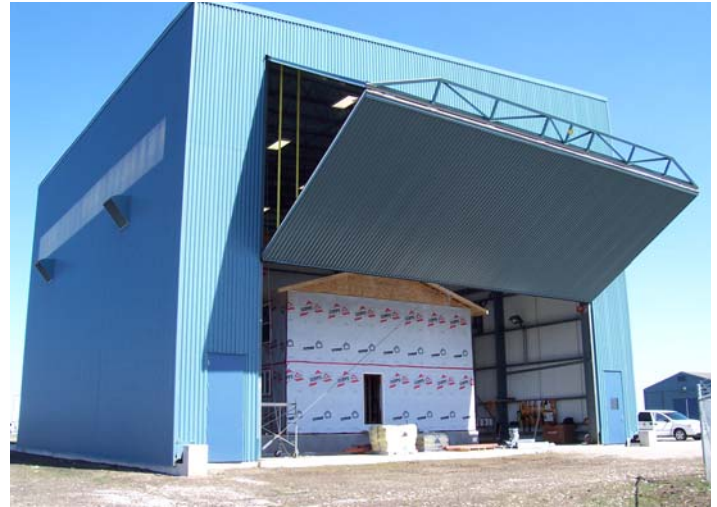
Figure 1. The hangar building covering the first house specimen (under construction).

Construction of the laboratory space was completed in Fall 2005 at a site at the London International Airport, London, Ontario. Figure 1 shows a photograph of the “hangar” building, as we are calling it. The hangar building is mounted on rails so that it can be moved to allow the house (seen inside, under construction) to be exposed to the natural environment. When the large, bi-fold door is opened completely, the hangar can slide past the house. The house is constructed to current Canadian standards, including climate control. The west wall of the house, the one in view in the photograph will be instrumented with heat, moisture and mould sensors to evaluate its performance over the winter of 2006-7. Figure 2 shows a photograph of the house, with the brick being installed by students from Fanshawe College, London.

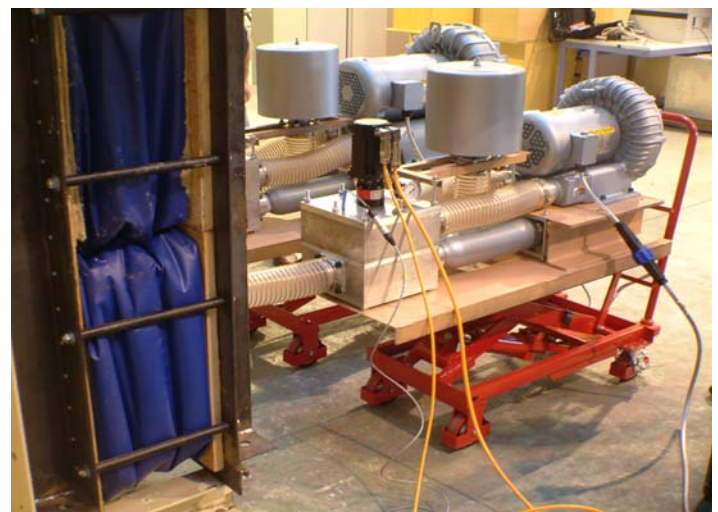
Figure 4. Photograph of two prototype pressure loading actuators connected to the (blue) pressure boxes, the flexible membranes connecting the PLAs to the house surface to allow the pressures to be applied.

Figure 3 shows a time history of pressure from a 0.36 m² area near a roof corner, obtained from a wind tunnel experiment and scaled for a full-scale 3-second gust speed of 360 km/hr (i.e., extreme Category 5 conditions). This is a typical 10-minute segment of a pressure trace that a pressure loading actuator, for that area, must be able to replicate, and which the prototype loading system has already replicated to within 2%. The particular challenge, quite beyond what the BRERWULF system could accomplish, is to do this with high leakage flows. The requirements for the peak attainable pressures and flow rates are given in Table 1, as well as the required frequency response of the pressure loading actuators to smaller (1-2 kPa) fluctuations. Figure 4 shows a photograph of two prototype pressure loading actuators connected to pressure boxes.
