# THE WIND ENGINEER

December 2006

## Performance of Glass/ Cladding of High-Rise Buildings in Hurricane Katrina

## Stability of Portable Toilets During Wind

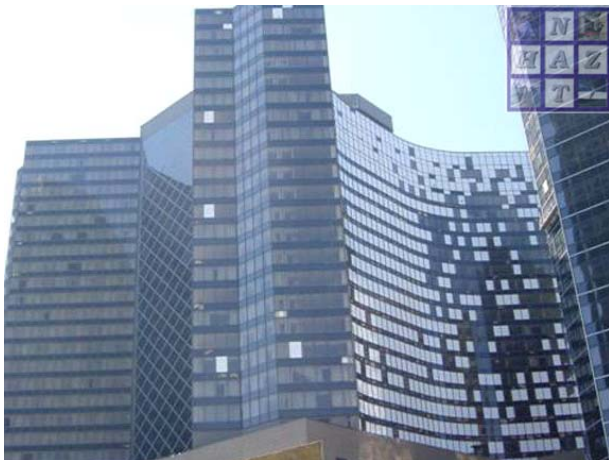
**Figure 3** East and north faces of Hyatt Regency Hotel.

The Hyatt Regency Hotel, located near the Superdome, suffered significant glass and cladding damage, especially on the north face of the hotel (See Figure 3). Nearly every window on the north face of the hotel was broken as it experienced not only high winds during the storm,

but also wind with debris accelerating through the canyon formed by the upwind buildings. Some of the falling glass during its downwards trajectory damaged glass at lower levels, initiating a domino effect causing more damage to windows below. Along with the glass damage, the building roof was also significantly damaged. Large portions of the roofing material were torn up and missing. There was evidence of abrasions on certain faces of the various roof structures, including the round center tower, and evidence of façade elements ripped off at several corners. The debris found on the property included gravel, fasteners, and large pieces of glass likely from upwind buildings. In addition, the inside of the hotel was heavily damaged with walls torn down and room contents scattered everywhere (See Figure 4).

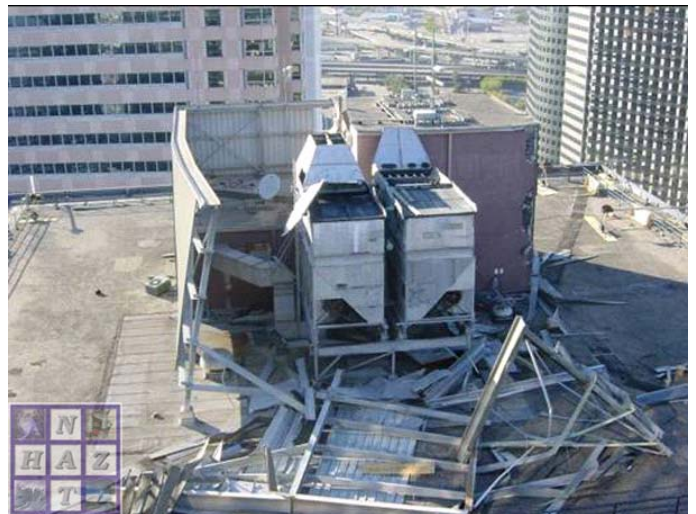
**Figure 5** Rooftop penthouse on Amoco Building was nearly destroyed

The Amoco Building sustained a large amount of glass and cladding damage as well as damage to the rooftop penthouse (See Figures 2 and 5). A large percentage of the windows were broken and boarded up with plywood. Of the windows that were not covered, many of them showed pitting where a missile had impacted the window. The roof of the Amoco Building originally had a layer of loose pea gravel several inches thick that covered the built-up roof surface completely. The wind blew off much of the gravel, piling some up along the south parapet and exposing sections of tar. The penthouse

structures on the roof suffered considerable damage, as their large beams had been blown off supports and their connections torn out of the cinder block wall. The four columns that supported the penthouse had all been pushed away from the supports - one was missing from the rooftop. It appeared that the bolts that held the steel columns to the concrete bases had been sheared off. Most of the penthouse cladding had been blown off; some large components were found on an adjoining low-rise building south of the Amoco Building.

Another cause of damage can be contributed to poor connections and lack of redundancy. This applies mostly to roof top structures. Nearly all of the damaged penthouses had missing siding at the corners associated with high levels of suction. For example, the round tower on the roof of the Hyatt was missing siding on the north face. Also, miscellaneous fasteners were found on the roof of the Hyatt among the debris. Another example of inadequate connections and bracings was the penthouse on the Amoco Building.

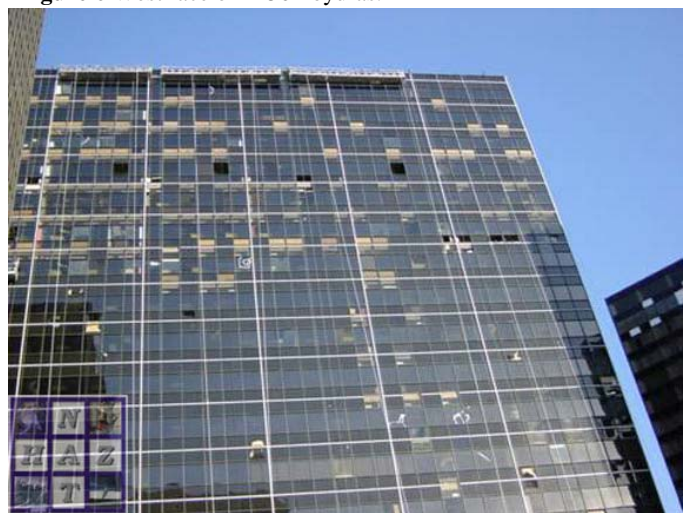
**Figure 6** West face of 1250 Poydras.

The building known as 1250 Poydras also suffered damage to the glass and cladding, especially on the north face (See Figure 6). The old gravel roof of this building had been replaced two years ago; however, the roofing membrane had bubbled up in the northeast corner. Additionally, a roof drain had been pulled up. The penthouse was in good condition with exception of the loss of one

large door. Overall the roof of 1250 Poydras performed satisfactorily. However, some debris from different sources was found.

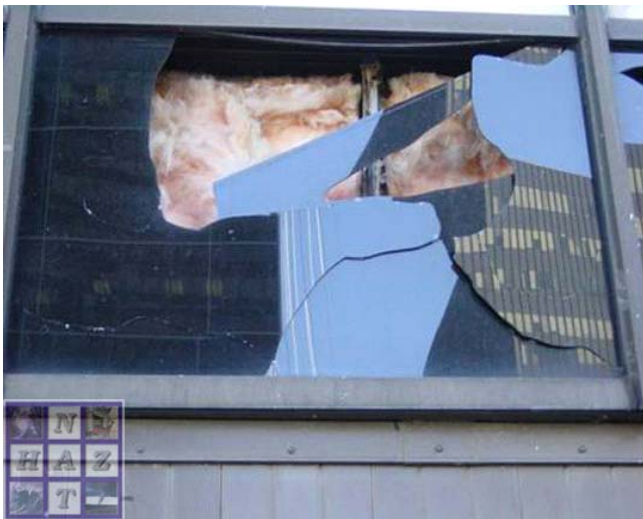
**Figure 7** Broken window on north face of Hyatt Regency Hotel, likely caused by missile impact.

The gathered evidence suggests that the majority of the damage was likely caused by wind-borne debris. The wind-borne debris included pea gravel, rooftop appurtenances, siding, and penthouse structures which became airborne and caused significant damage to the glass and cladding of the surrounding buildings. The finding of gravel, glass shards, pitted glass and other debris on or inside buildings supports this scenario. The breakage patterns to the spandrel glass supports the missile impact theory due to the appearance of impact-induced pitting with cracks that spread from the impact point (See Figure 7 and 8). Given the orientation of the buildings in relation to the damaged areas and the availability of wind-borne debris from upwind buildings, it is conjectured that the main debris source was the gravel roofs and appurtenances of upwind buildings.

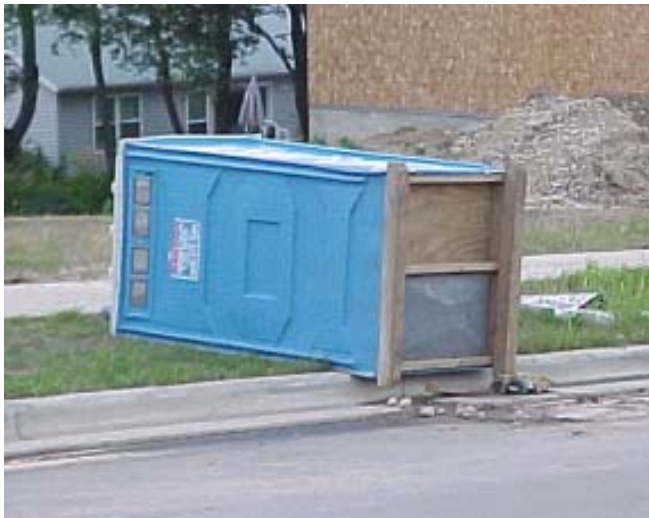
Figure 1: Overturned portable toilet

Single cubicle portable toilets are a feature of many recreational events such as sporting fixtures and outdoor concerts. They are, however, susceptible to being blown over during strong wind events causing distress, danger and fouling to occupants and some bystanders (although many bystanders do gain a deal of amusement). Figure 1 illustrates an overturned cubicle.

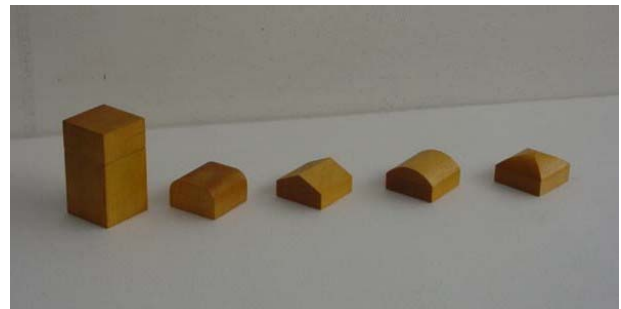
Figure 2: Model portable toilet with various roofs

A six-degree of freedom base balance was used for the 1:25 scale model testing of a typical portable toilet: 1.8 m high by 1 m square at the base. The model was tested with various roofs as shown in Figure 2. Along-wind base overturning moments were normalised according to Equation 1 and presented in Figure 3 for the various roof configurations.

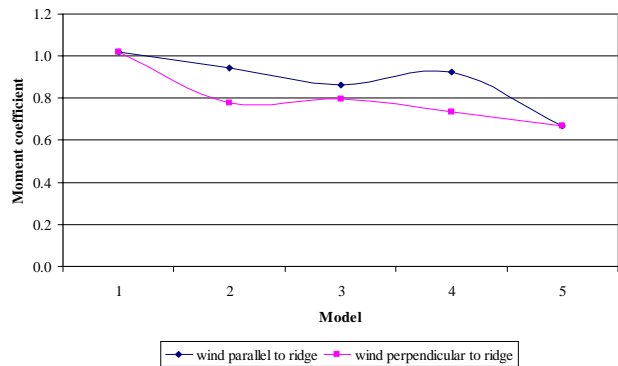
Figure 3: Moment coefficient for isolated portable toilet

It is unsurprising that as the degree of rounding increases the moment coefficient decreases.

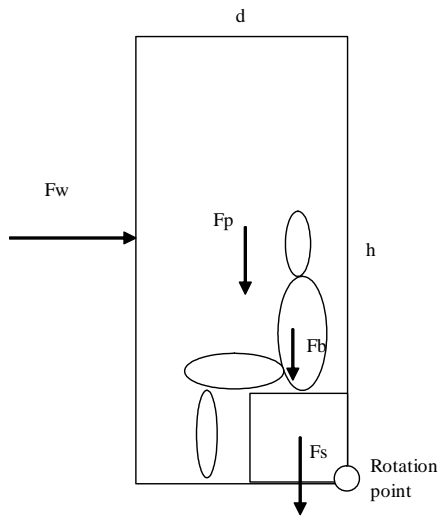
**Fig 3:** Free body diagram of occupied portable toilet

Combining the wind tunnel information with the free body diagram, Figure 3, and assuming quasi-steady conditions the gust wind speed required to destabilise the portaloo for an average person with an empty or full tank is given in Table 2.

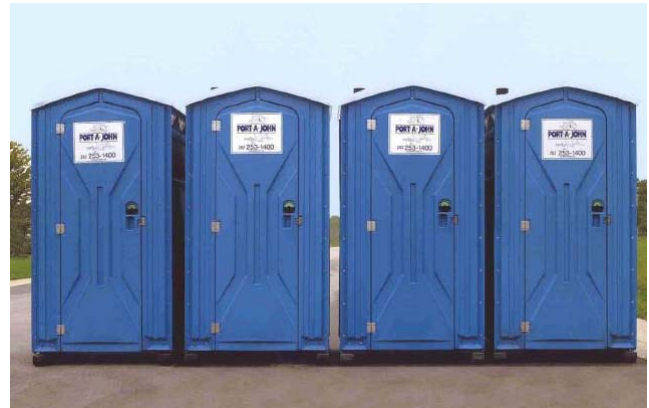
**Figure 4:** Typical group of four portable toilets

Toilets are often used in groups as shown in Figure 4, and optimum spacing of the toilets may help significantly in increasing their wind performance. This is the subject of further wind tunnel testing.

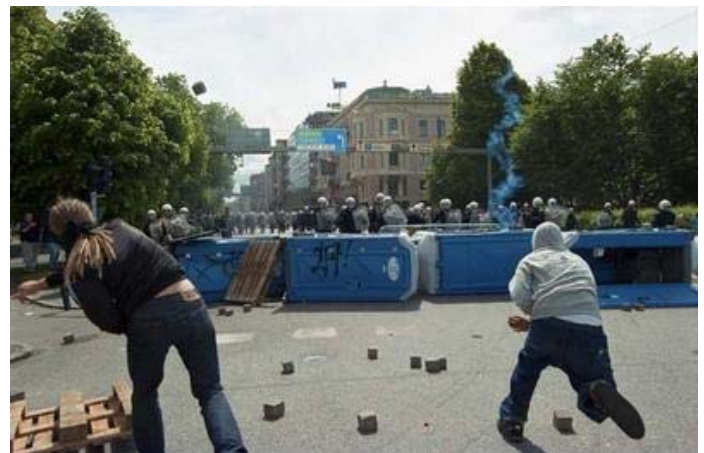
**Figure 5:** Intentionally overturned portable toilets

Wind tunnel tests have shown that portable toilets may be dangerous during even moderate wind. The importance of securing the toilet before use can not be overstated. Further work is being done to develop guidelines for safe toilet use. These will, however, not prevent deliberate misuse of toilets for purposes for which they were not intended (see Figure 5).
