THE WIND

ENGINEER

TUSCALOOSA AND JOPLIN TORNADOES: PRELIMINARY OBSERVATIONS

FEMA MITIGATION ASSESSMENT TEAM (MAT) INVESTIGATES TORNADO DAMAGE

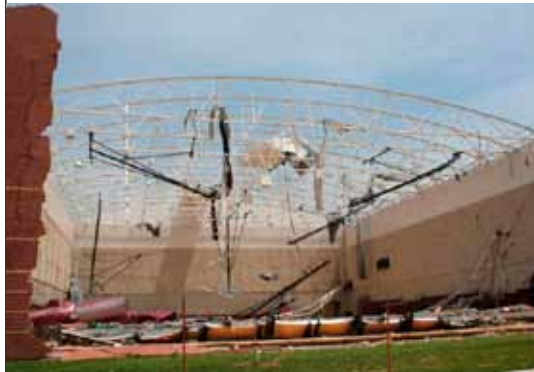
Figure 1:
Exterior wall collapsed – no connection at footing

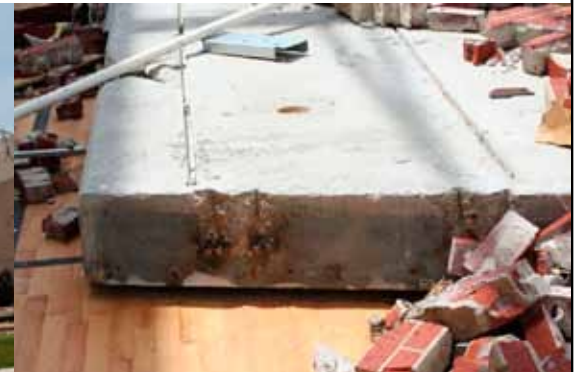
Figure 2:
Puddle welded connection on top of wall failed

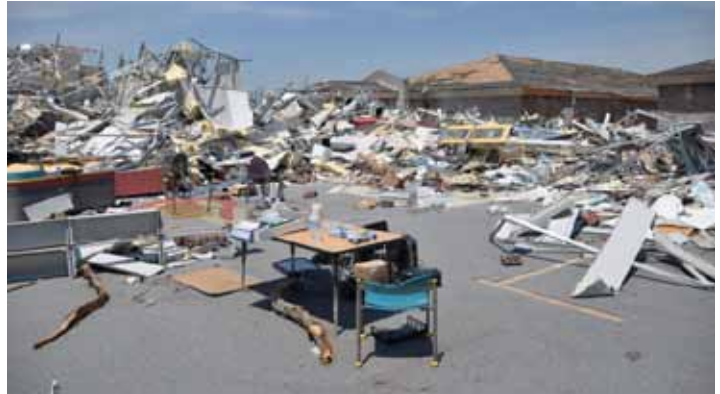
Figure 1: This ten year old one story school had three classroom wings and a central core area. One classroom wing and most of the central core collapsed. This is a view of the central core area.

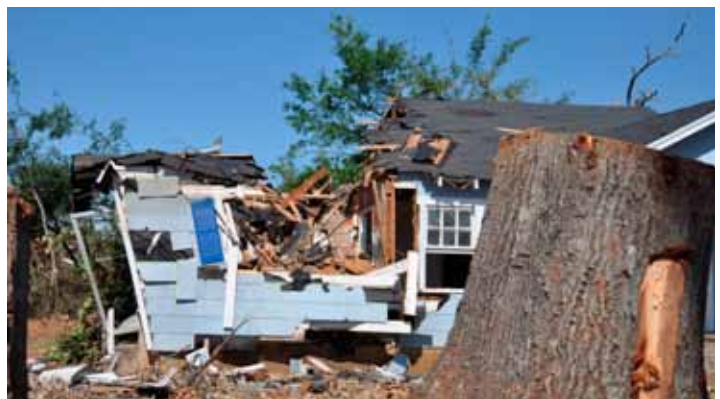
Figure 2: Tree fall caused severe building damage.

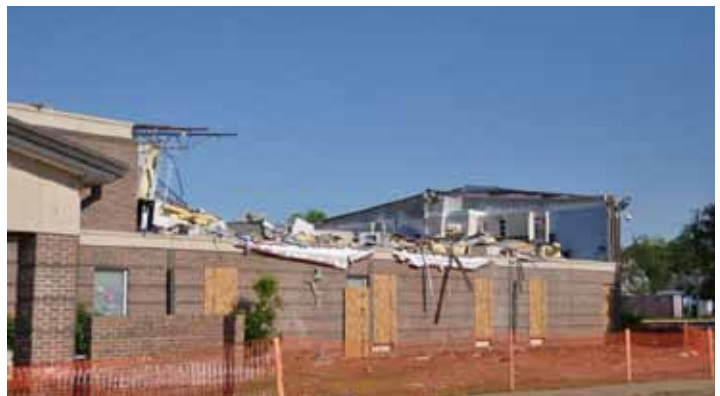
Figure 3: Most of the second floor of one wing collapsed at this 14-year-old school. It had a steel frame with CMU/brick veneer exterior walls.

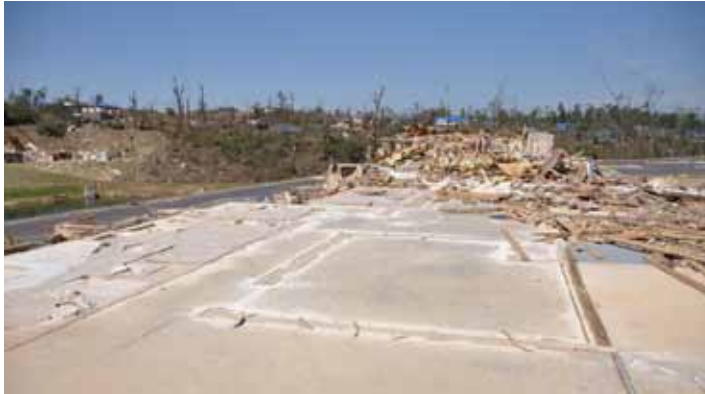
Figure 5: At this unit all of the walls were blown away.

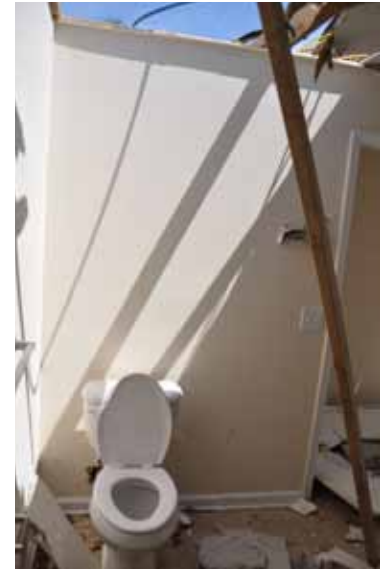
Figure 6: The roof structure blew away at this unit. Interior bathrooms such as this one often provide safe refuge during weak or strong tornadoes. However, a 2x4 and other wind-borne debris entered this bathroom. This illustrates the importance of having a safe room as recommended in FEMA 320. <http://www.fema.gov/library/viewRecord.do?id=1536>

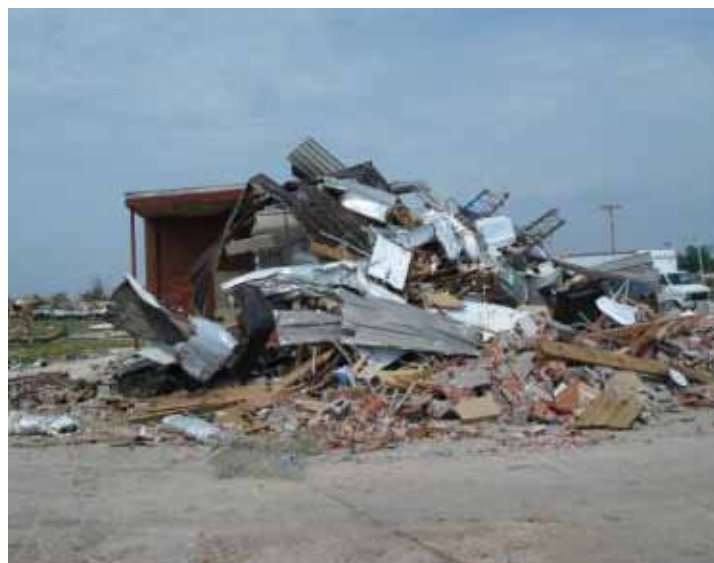
Figure 6: Post Office, Smithville, MS

In Smithville the team completed detailed assessments on the post office, police station and town hall and captured high-definition geo-referenced video of the town (Figure 5). Both the police station and town hall were completely collapsed, and only a small portion of the post office, containing the bathrooms and electrical room, was left standing. A detailed assessment was not completed on the Smithville school structures but it was observed that the buildings sustained roof damage throughout. Also, one large residential area experienced severe damage, with the majority of buildings suffering complete destruction. The team was fortunate to speak with Gregg Kennedy, the current mayor of Smithville. Mayor Kennedy gave his personal recount of the event and spoke of sheltering under a conference table as the building surrounding him was destroyed. Approximately two-thirds of the community was severely damaged by the tornado that passed through Smithville, MS on April 27.
